Manhole Inspection Summary

Manhole # S41I__038MH

Insp Date: **5/15/08 3:57 PM**

Location Address: **rear 404 eden st**

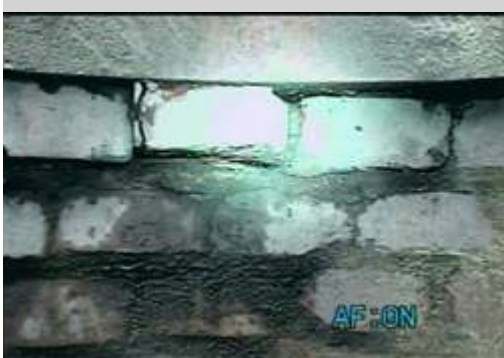
Defect 1

Condition: ☐ Sound ☐ Cracked ☐ Root Intrusion ☒ **Loose Brick** ☐ Deteriorated

Infiltration: ☐ None ☒ **Joint** ☐ Cracks ☐ Mortar ☐ Roots ☐ Wall

corbel cracked with infiltration from joint and loose bricks

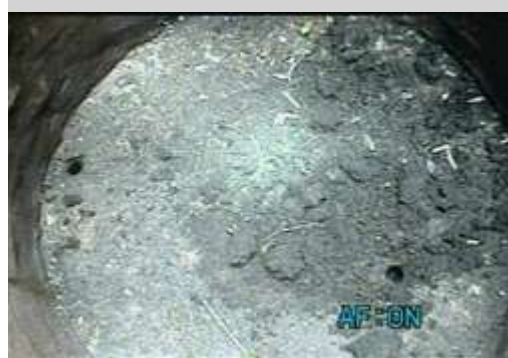
Defect 2

Condition: ☐ Sound ☐ Cracked ☐ Root Intrusion ☐ Deteriorated ☐ Leaks ☒ **Debris**

channel debris

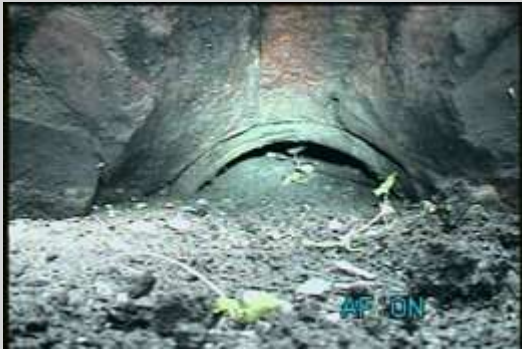
12 O'Clock Outflow

8 in. Circular Gravity Sewer
Pipe Out @ 12 O'Clock

Deposits: ☐ None ☐ Mud ☐ Sludge ☒ **Debris** ☐ Grease

Silt Depth: **7** (in.) Deposits Extent: **Heavy**
